## STS-104 FLIGHT READINESS REVIEW

# BACKUP INFORMATION

# STS-98 IN-FLIGHT ANOMALIES BACKUP

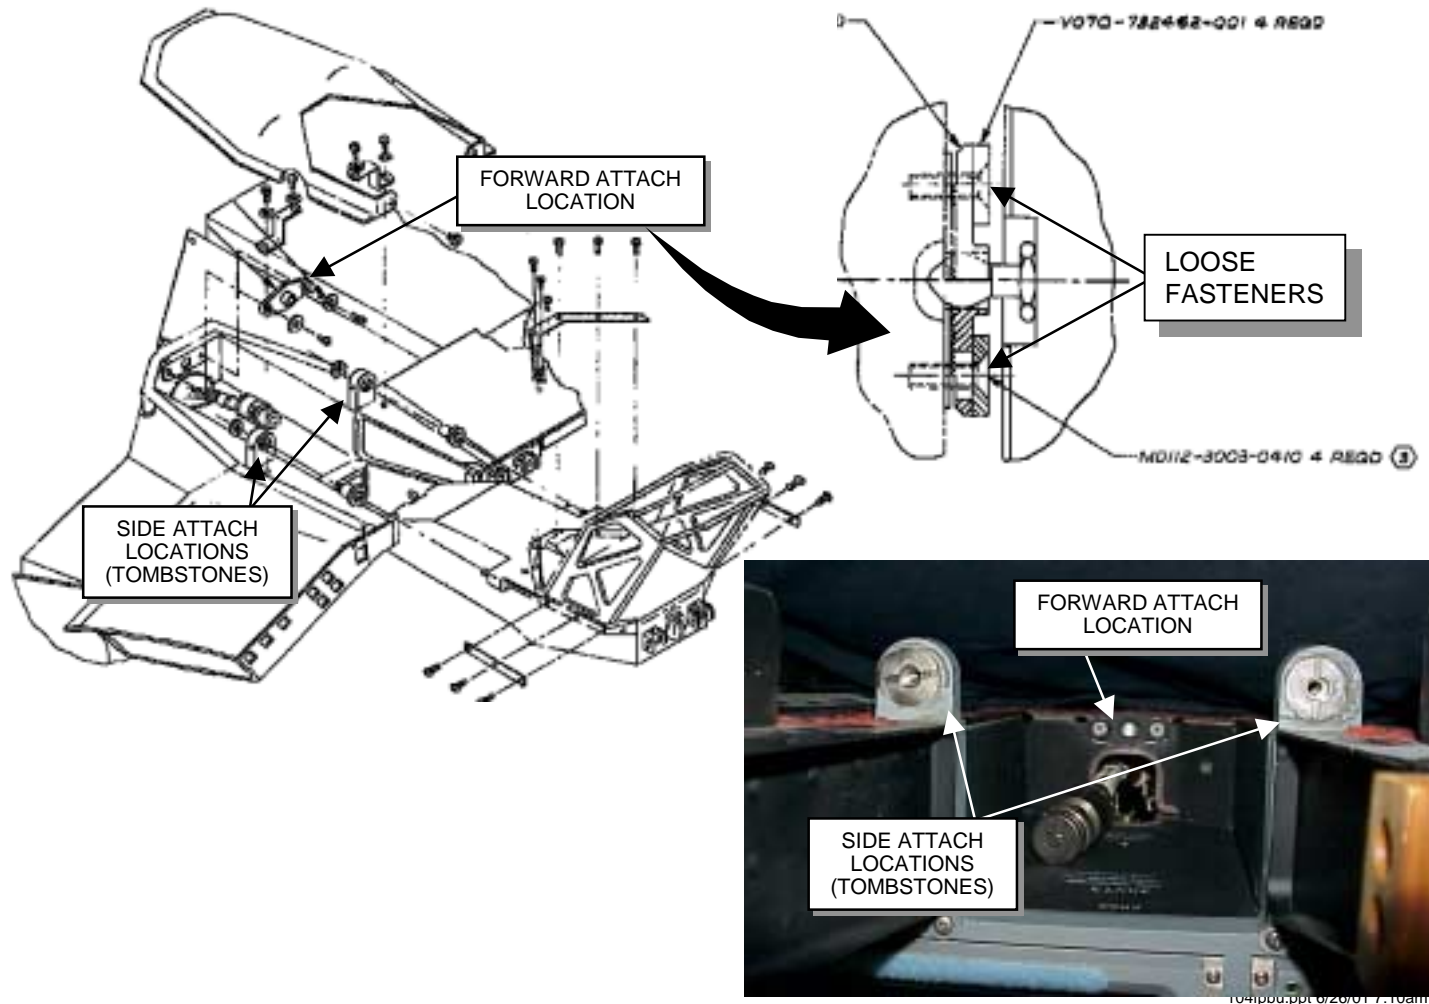
## HUD Assembly Detail

- Review of pilot-point-of-view (PPOV) video and crew debrief from STS-98 revealed the pilot and commander HUDs were misaligned as much as two runway widths during final approach
- Calculations based on altitude and approach angle indicate misalignment on the order 55 minutes of right yaw (16 milliradians or 0.9 degrees)

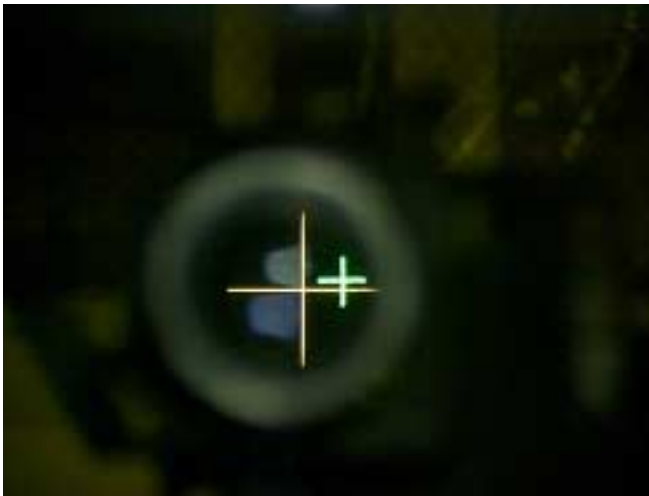
COMMANDER HUD CHECK

- HUD optical alignment GSE was installed in OV-104
  - Initial alignment check with retorque of forward attach showed both CDR and PLT HUDs misaligned approximately 34 minutes of right yaw (vs +/- 15 minutes required by specification)

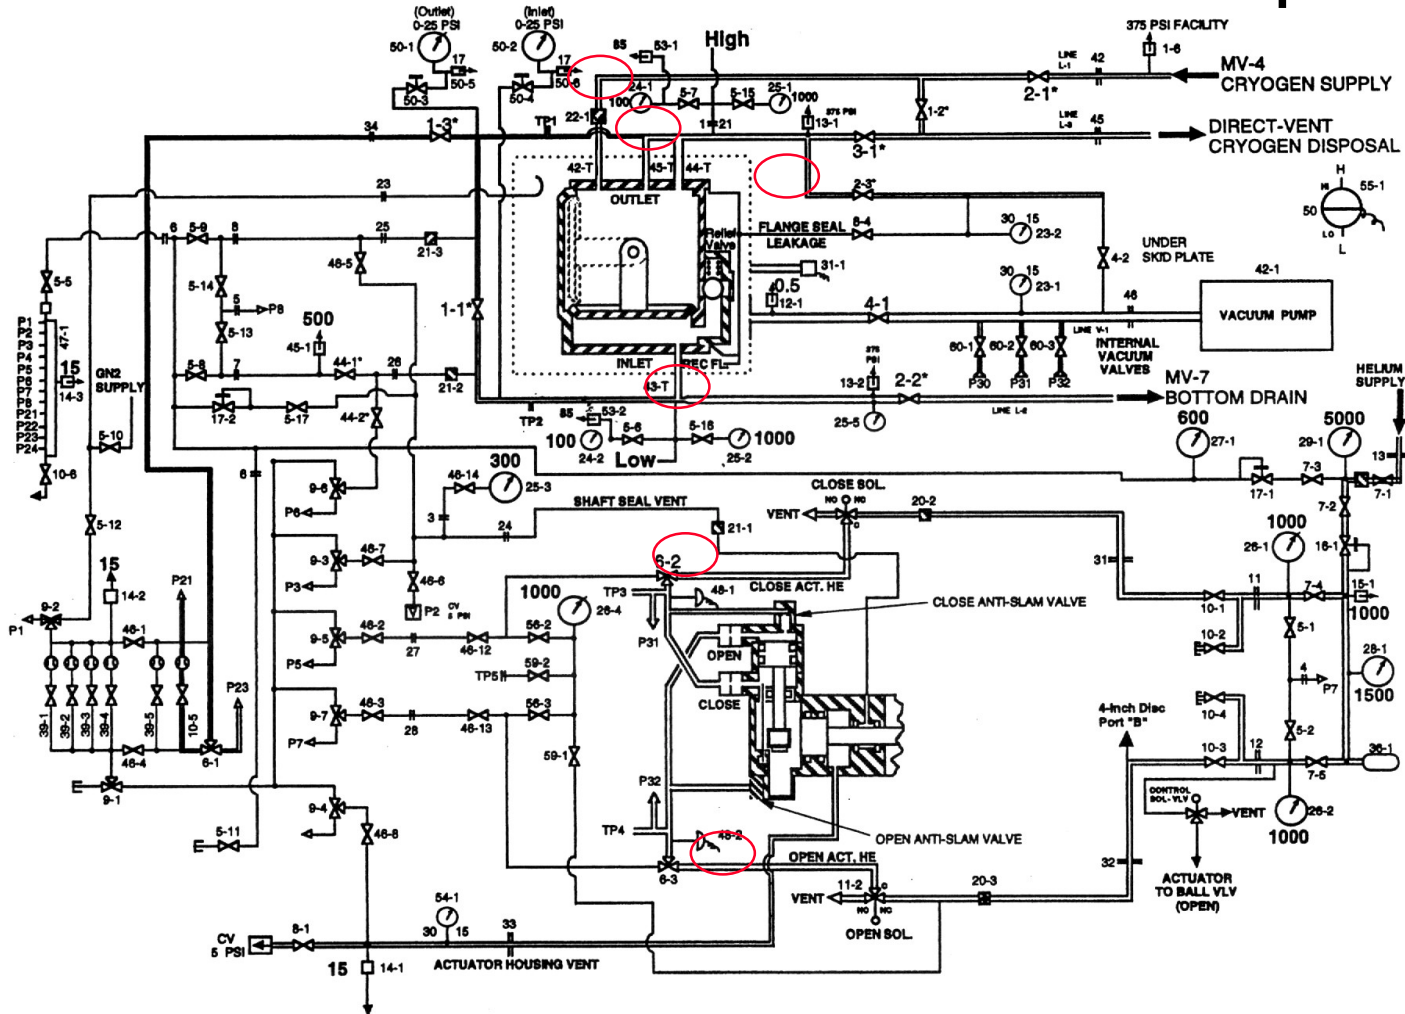
## NSLD contamination vs. distance test setup

- Level of contamination steadily decreases as distance from pump increases
  - No oil present in straight lines
  - Collection is in convoluted flexlines and test flanges
  - convolutes are prone to entrap particulates
  - Test flange configuration lends to evaporative deposit during LN2 fill & dispose sequences
